Inspection Report
5220 Mockingbird Lane.
Atlanta, GA 30328.
Prepared for: Mr and Mrs J.B. Hart.

Report Index

5220 Mockingbird Lane
Atlanta, GA 30328

Inspection conducted by Paul Davidson
GAHI#345-98

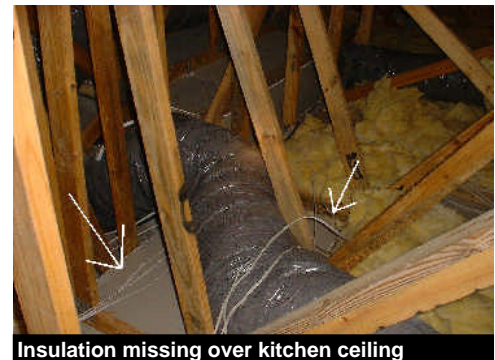
Fiberglass batts, Some insulation is installed unevenly over the kitchen area with poor general coverage. Recommend additional insulation in the attic area to improve energy efficiency.

Insulation missing over kitchen ceiling
